**FIELD SAMPLING TRIP REPORT
MARCH 30 THROUGH APRIL 2, 1998**

**NEW RIVER STORAGE DEPOT (NRSD) SITE
(Radford Army Ammunition Plant)
PULASKI COUNTY, VIRGINIA**

**U.S. ENVIRONMENTAL PROTECTION AGENCY
REGION III**

**GANNETT FLEMING, INCORPORATED
Harrisburg, Pennsylvania
with the assistance of**

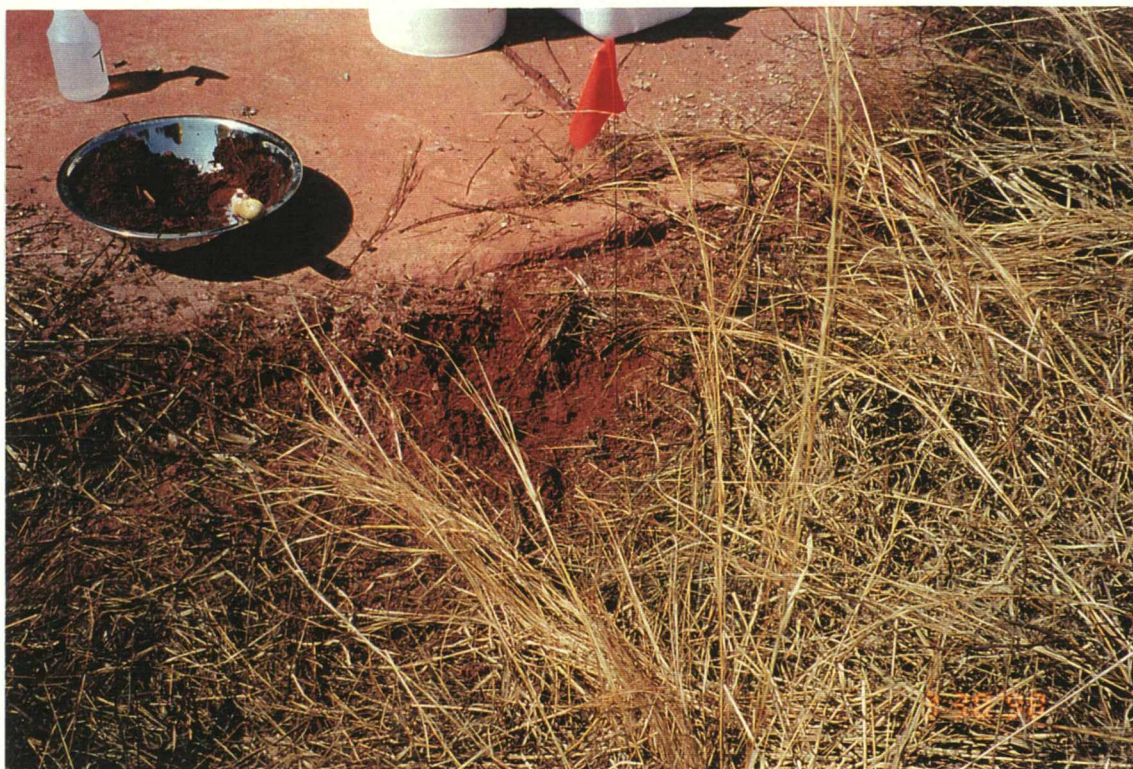
NRSD Photograph 5: Area B - Igniter Area
View of Sample SS-12 Sampling Location (TL 1-5)

- SS-12: A surface soil sample (0 to 2 inches bgs) collected at the location of SS-12 described above.
- SS-12A: A surface soil sample (1 to 2 inches bgs) collected approximately 18 feet south of SS-12 at the interior corner formed by the building's concrete pad. The ground had a red surface stain from the "red anti-spark material"; the sample consisted of a gray, organic soil beneath the red staining.
- SS-12B: A surface soil sample (3 to 4 inches bgs) collected beneath the SS-12A sample. The soil was a brown clay layer; some red matter was present.
- SS-12C: A surface soil sample (3 to 4 inches bgs) collected approximately 15 feet east of the concrete pad of the building on a line approximately perpendicular to the concrete pad at the SS-12 sampling location. The soil consisted of an orange clay.

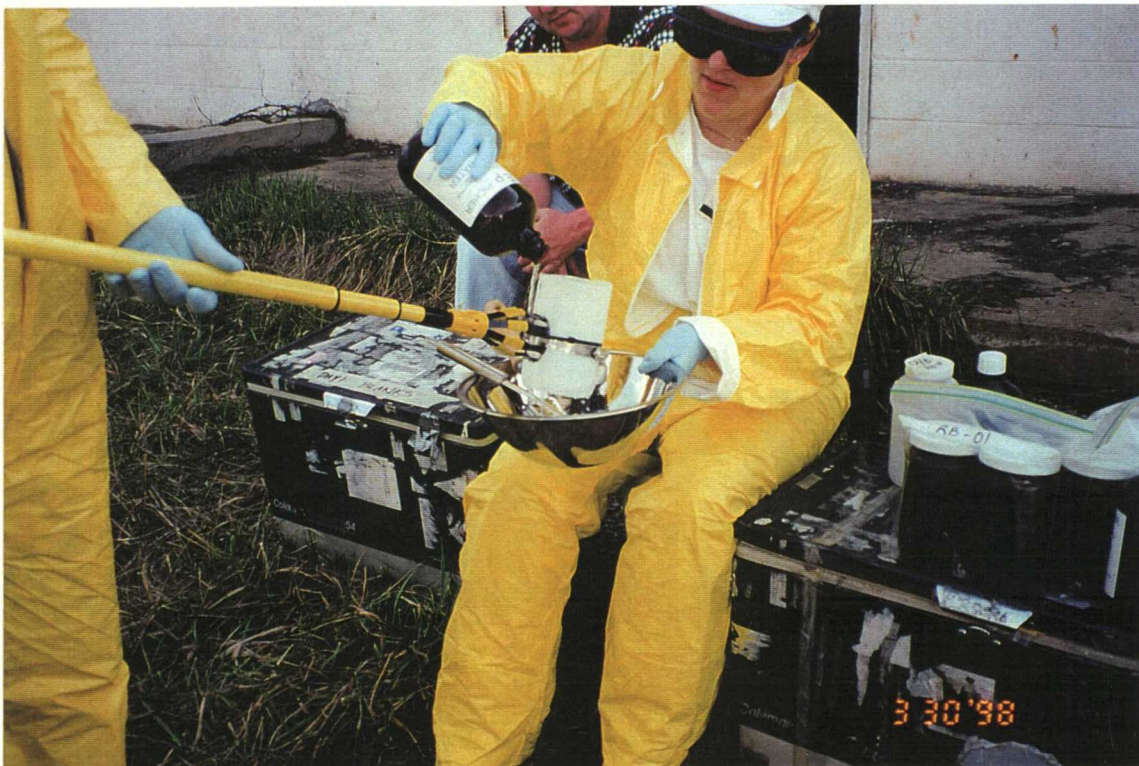
NRSD Photograph 27: Area H - Bag Loading Area
View of Rinsate Blank RB-01 Collection (TL 1-12)

RB-01: The rinsate blank was prepared by running the reagent grade water and DIUF water over the decontaminated surface water sampling apparatus and into a clean stainless steel bowl with a clean trowel, clean spoon, and clean putty knife before pouring into the bottleware (Photograph A-27; Figure D-19).

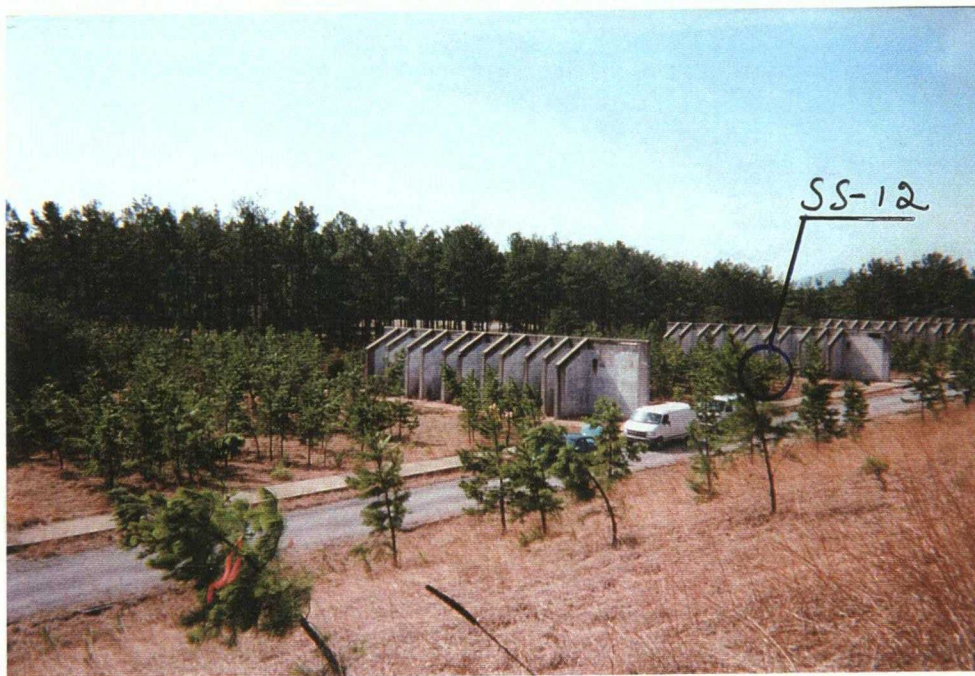
- TR-01A: Surface soil sample (1 to 2 inches bgs) collected from the depression caused by the former utility pole.
- TR-01B: Surface soil sample (1 to 2 inches bgs) collected from southwest of the depression.
- TR-01C: Surface soil sample (1 to 2 inches bgs) collected near the base of the fallen utility pole near the depression.
- TR-01D: Surface soil sample (1 to 2 inches bgs) collected from southeast of the depression and base of the fallen utility pole.

**NRSD PHOTO 1 - (Test Kit Screening Site): Igniter area looking at RDX/TNT site SS-12.
Photo taken at location of PCB screening samples TR-01 A-D.**

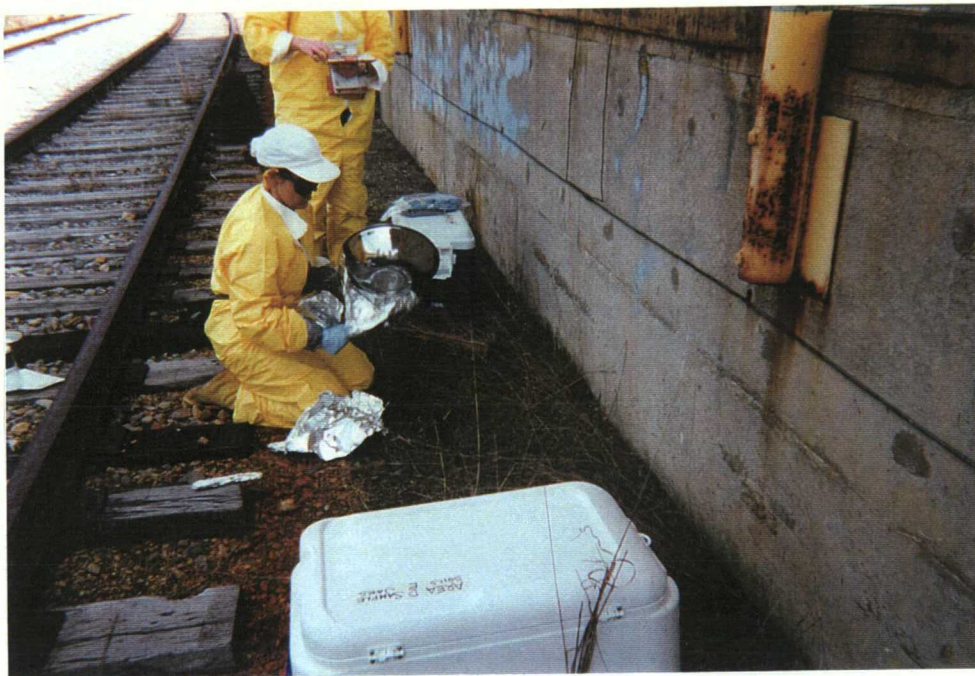
NRSD PHOTO 5 (Test Kit Screening Site): Rail yard, north side of transfer platform 603, site of RDX/TNT screening samples SS-08 A, AA, AB and AC.

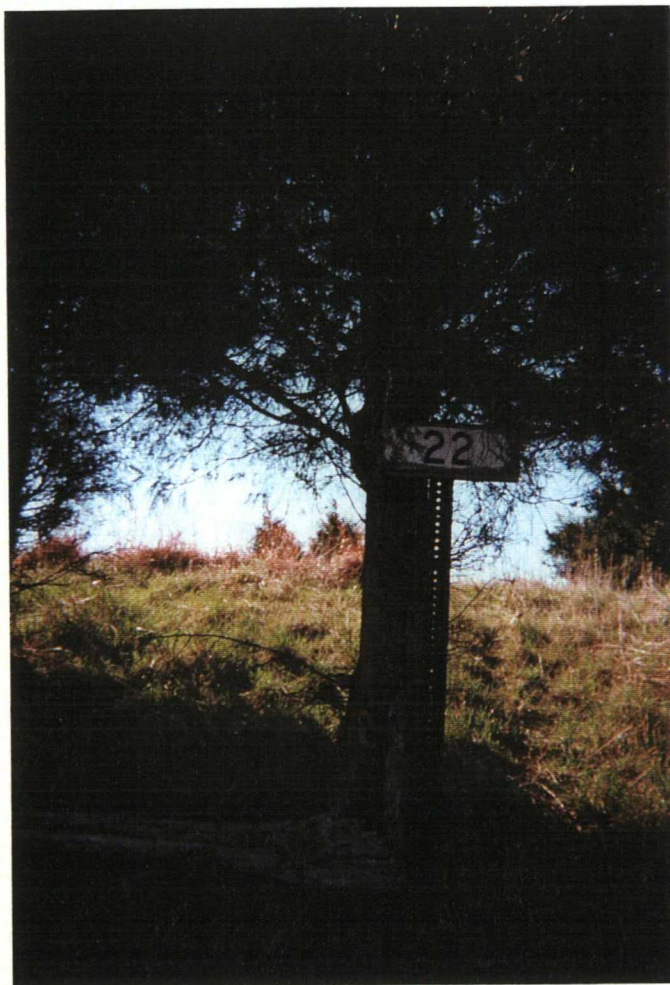
The samples collected for PCB field screening were from the vicinity of a suspected former utility pole (Photograph B-6; Figure D-15). The area was located northeast of Bag Loading Building 405. The utility pole was not located, however, a sign labeled "22" was present. The sign was similar to those observed to be placed near other utility poles with transformers attached. Historical maps indicate a transformer was located in this area. The following samples were collected from soil between 6-inch grass hummocks.

NRSD PHOTO 6 (Test Kit Screening Site): Bag Loading Area E, location of PCB screening samples at screening samples TR-03 A-F.

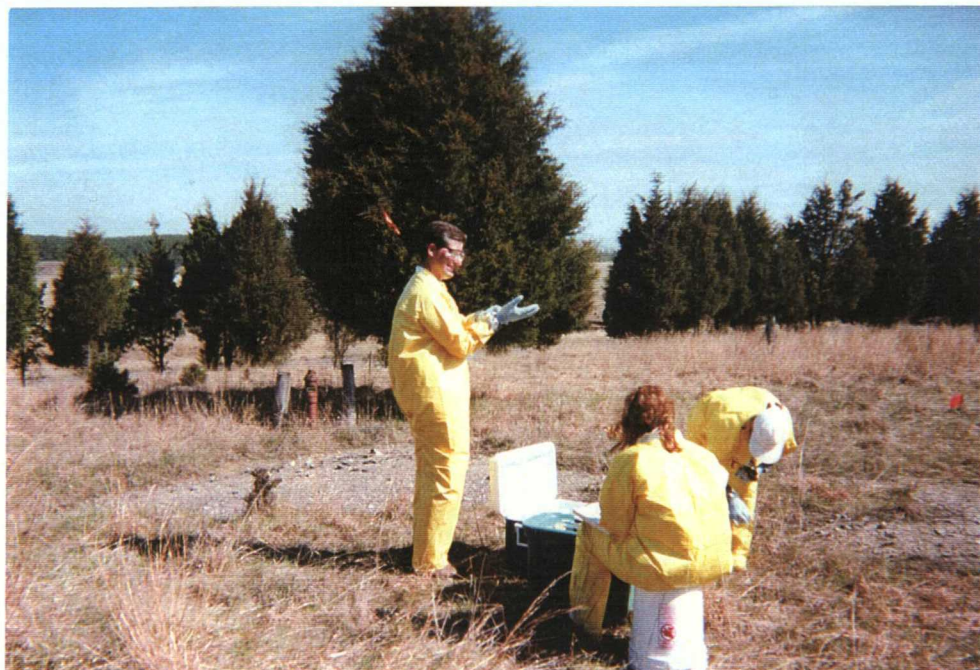
NRSD PHOTO 8 (Test Kit Screening Site): Bag Loading Area E. Stressed soil area. Sample taken next to gravel driveway (former access road to fire hydrant). RDX/TNT screening sample SS-14.

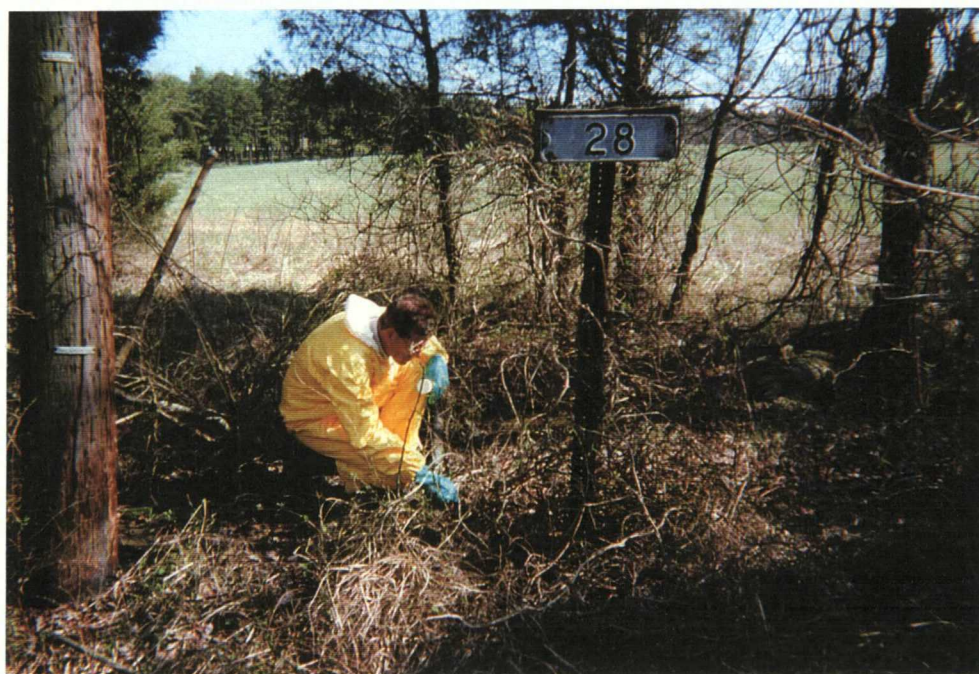
NRSD PHOTO 12 (Test Kit Screening Site): Bag Loading Area H location of transformer poles, crossbars, and debris. PCB screening samples TR-05 A-H.

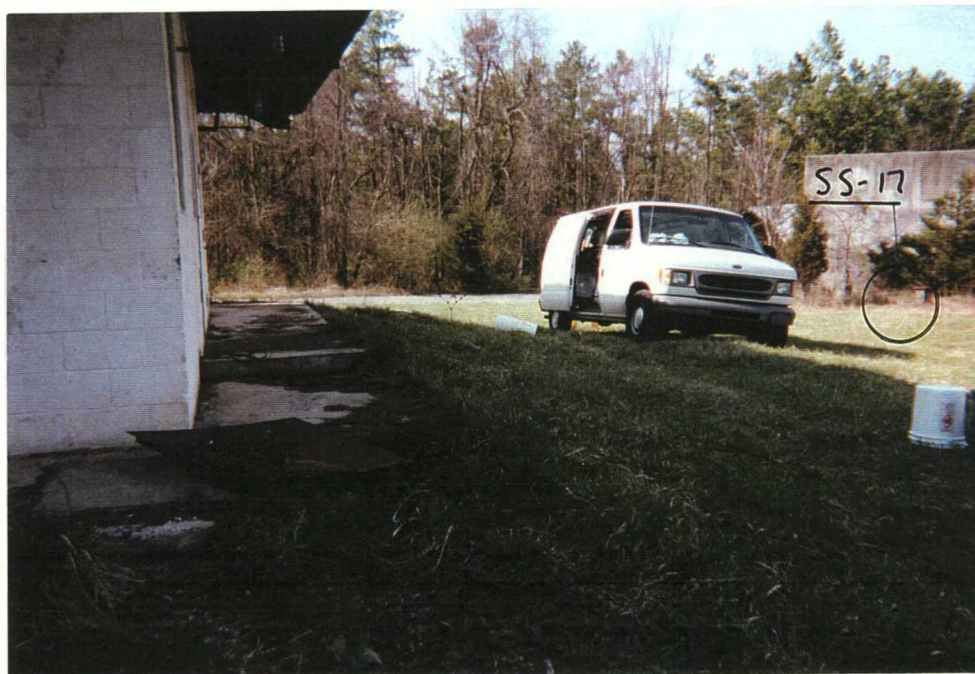
NRSD PHOTO 14 (Test Kit Screening Site): Bag Loading Area H. Igniter Service Magazine 466.
RDX/TNT screening sample SS-17.
